SHAFT BLOW-OUT HAZARD OF CHECK AND BUTTERFLY VALVES

CHEMICAL SAFETY

ALERT

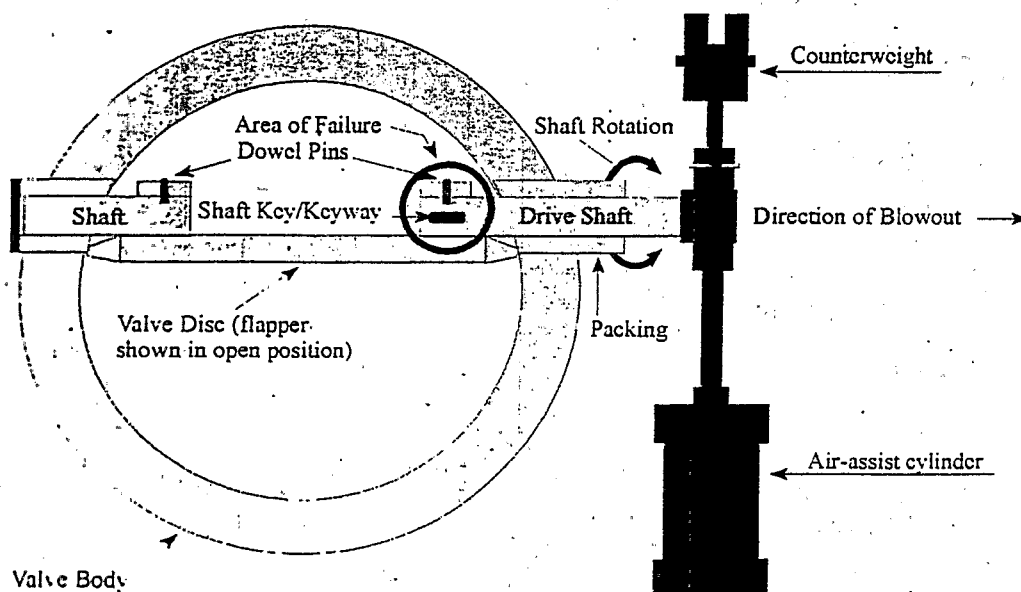
The check valve was designed with a drive shaft that connects the internal valve disk to an external pneumatic cylinder (see diagram on next page). The valve failed when a dowel pin designed to fasten the drive shaft to the disk sheared and a key designed to transfer

torque from the drive shaft to the disk fell out of its keyway, disconnecting the drive shaft from the disk. System pressure was high enough to eject the unrestrained drive shaft from the valve, carrying with it the external counterweight assembly, weighing over 200 lbs., a distance of 43 feet away.

Valves subject to this hazard may be designed with a two-piece valve stem (sometimes referred to as a "stub-shaft" design). In each of the cases described above, the malfunctioning component was a Clow stub-shaft Model GMZ pneumatically assisted swing check valve (see diagram below). In these check valves, one stem piece functions as a drive shaft that connects the internal valve disk to an external air-assist cylinder and counterweight assembly. The drive shaft penetrates the pressure boundary through a stuffing box. The exterior portion of the drive

Simplified cross-sectional view of check valve (flow direction is into page)

shaft is connected to a pneumatic piston and counterweight, and the interior portion of the shaft is coupled directly to the valve disk using a cylindrical hardened steel dowel pin and a rectangular bar key. This arrangement provides a power-assist to close the valve during compressor shut down, preventing reverse flow of compressed gases. These particular valves have probably not been produced since 1985, but still exist in some process facilities constructed before that date. Similar valves currently or previously produced and sold by other valve manufacturers may also be subject to this hazard.

Facilities should review their process systems to determine if they have valves installed that may be subject to this hazard. If so, facilities should conduct a detailed hazard analysis to determine the risk of valve failure. Check valves or butterfly valves which are subject to several or all of the above design and operational factors are at high risk for shaft blow-out. Detailed internal inspections may be necessary in order to identify high-risk valves. Facilities should consider replacing high-risk valves at the earliest opportunity with a blow-out resistant design. Several blow-out resistant designs of check and butterfly valves are available. If immediate valve replacement is impossible or impractical, facilities should consider immediately modifying the valves to prevent shaft blow-out. Valve manufacturers should be consulted in order to ensure that any modifications made are safe.
